# Fistula Salvage Utilizing the HeRO Vascular Access Graft in Dialysis Patients

James Lin, MD, Aaxess Partners, Vascular Access Center, Tampa, FL  
 Victor D. Bowers, MD, Surgery, LifeLink HealthCare Institute, Tampa, FL  
 James T. Huang, MD, Surgery, LifeLink HealthCare Institute, Tampa, FL

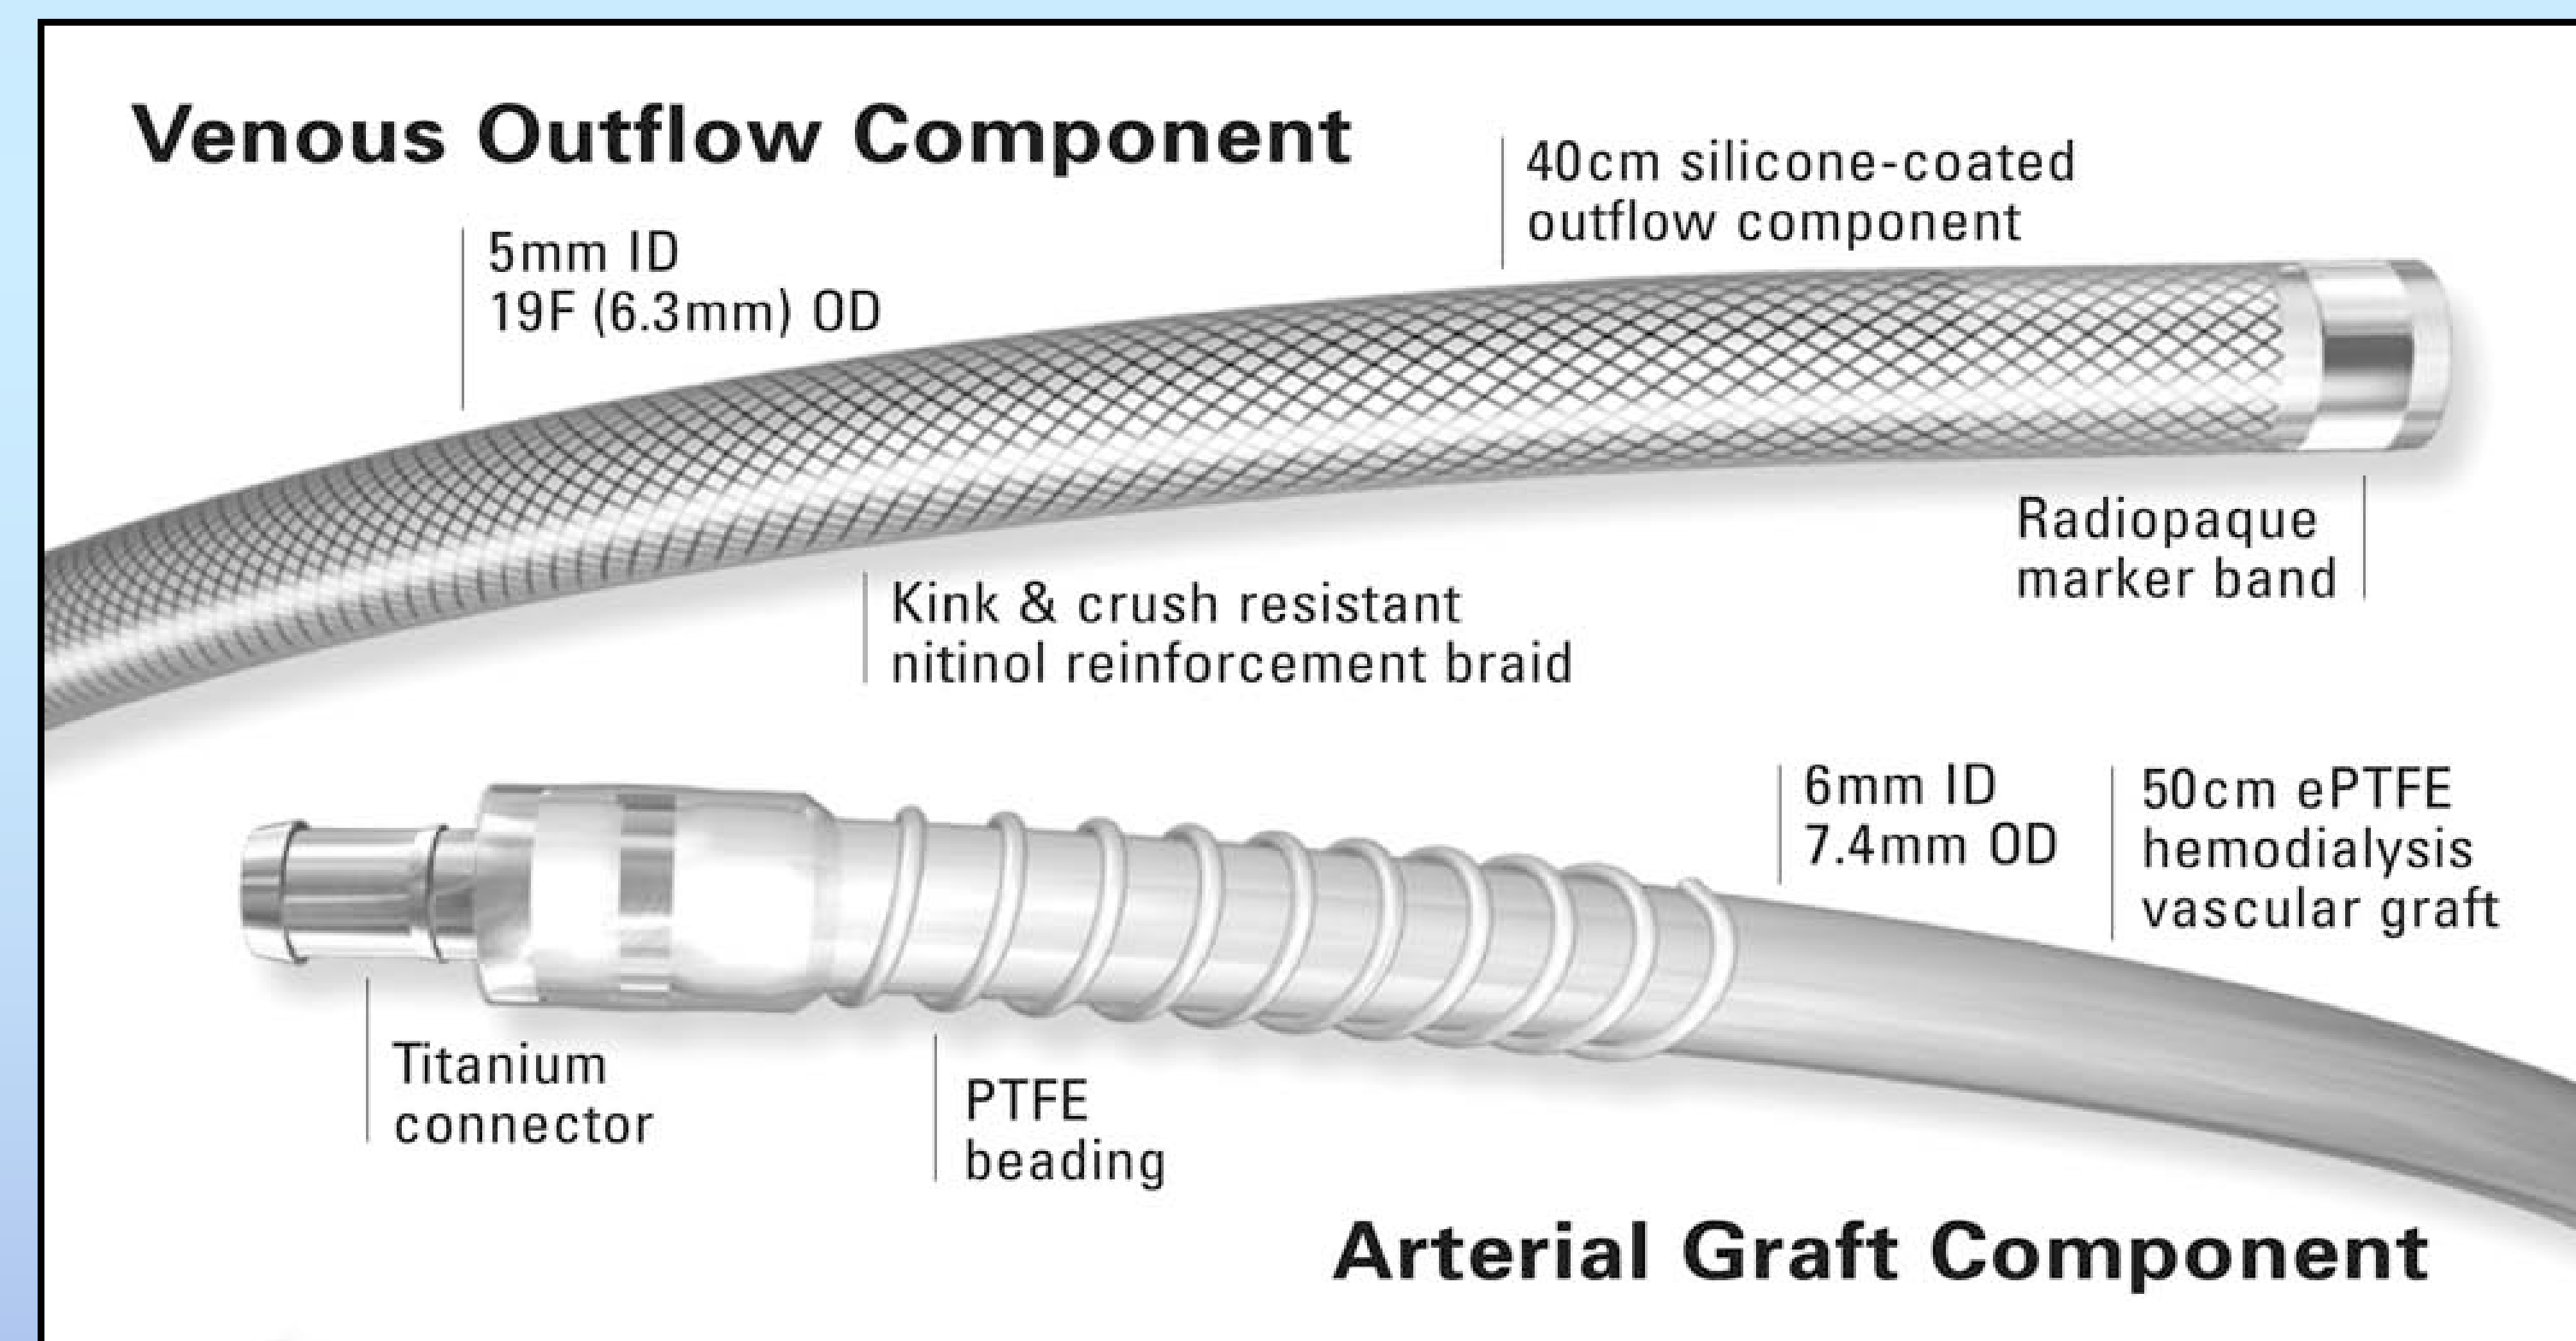
The HeRO vascular access device is a subcutaneous device implanted by a surgeon that provides continuous blood flow directly from an artery into the central venous system. HeRO is made up of two components, a standard ePTFE graft and a nitinol reinforced outflow component.

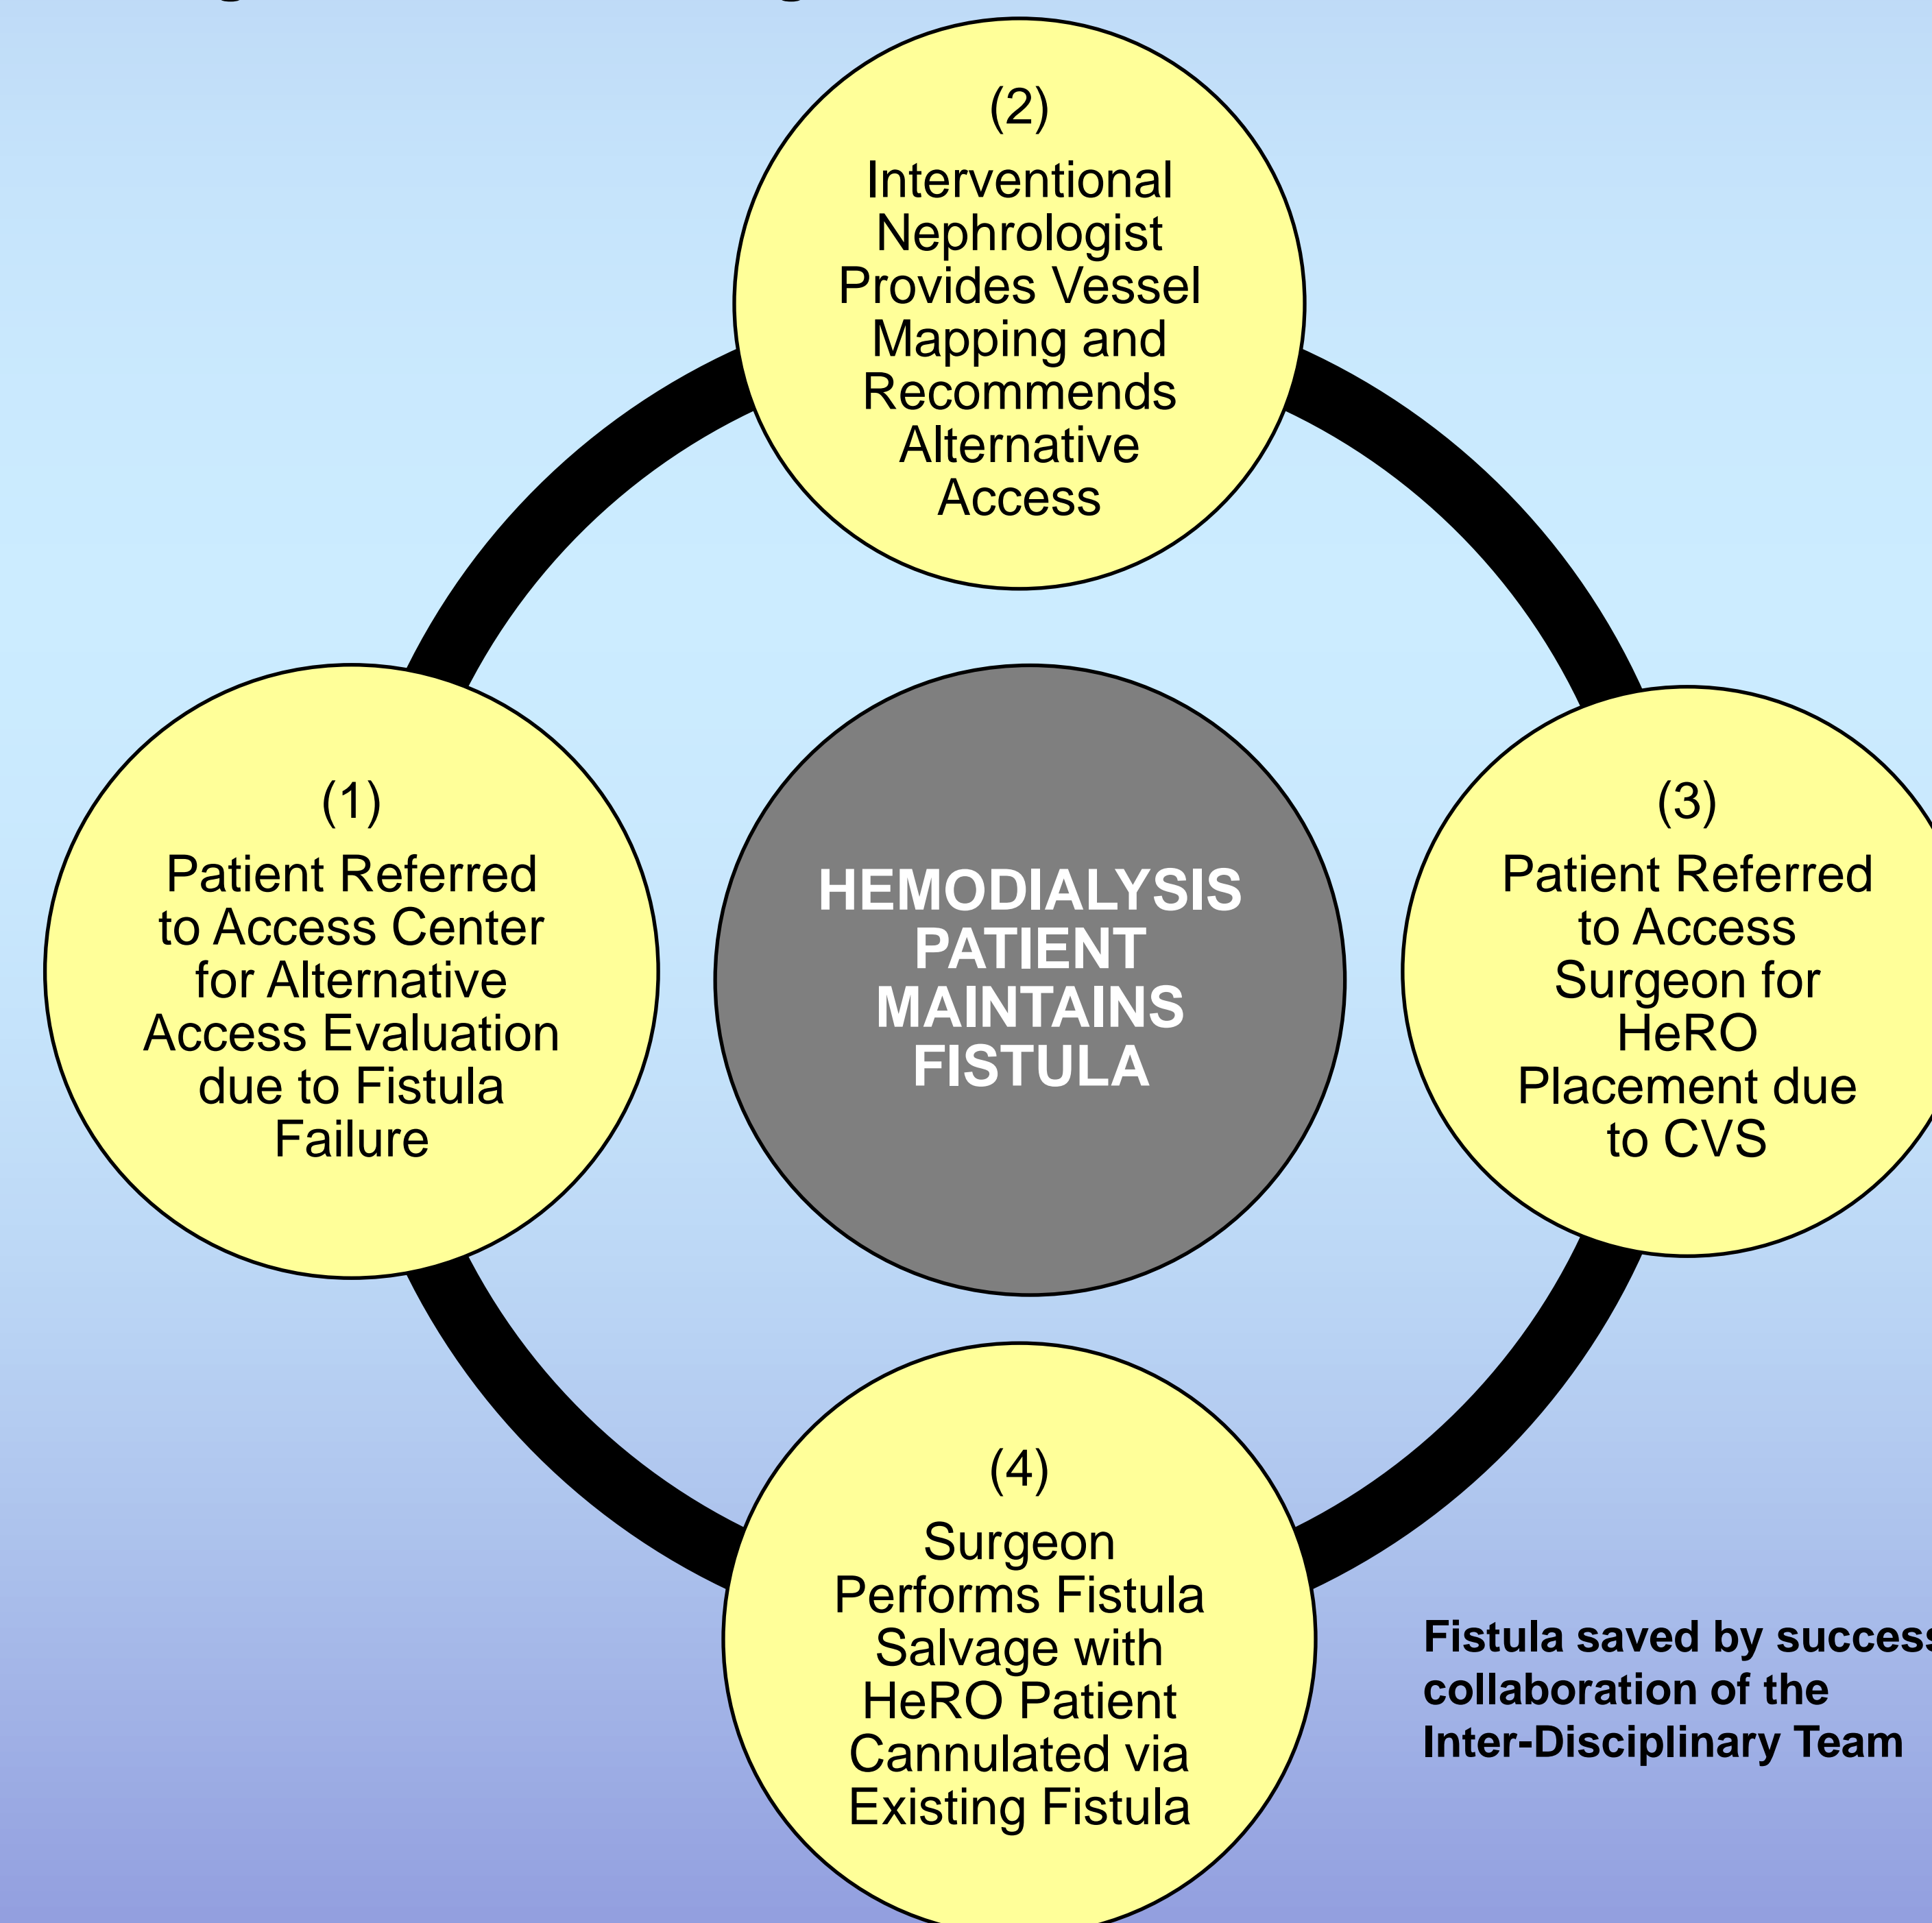
To date, in our access center, we have identified 13 patients for HeRO placement after reviewing their access history and conducting vessel mapping. An Inter-Disciplinary Team collaborated around the patient's access options and we have successfully avoided placing long-term catheters in two patients with failing fistulas due to venous outflow obstruction. To accomplish this, the HeRO device arterial graft component is cut to the appropriate length for the anastomosis to the existing fistula. The existing fistula remains the cannulation location.

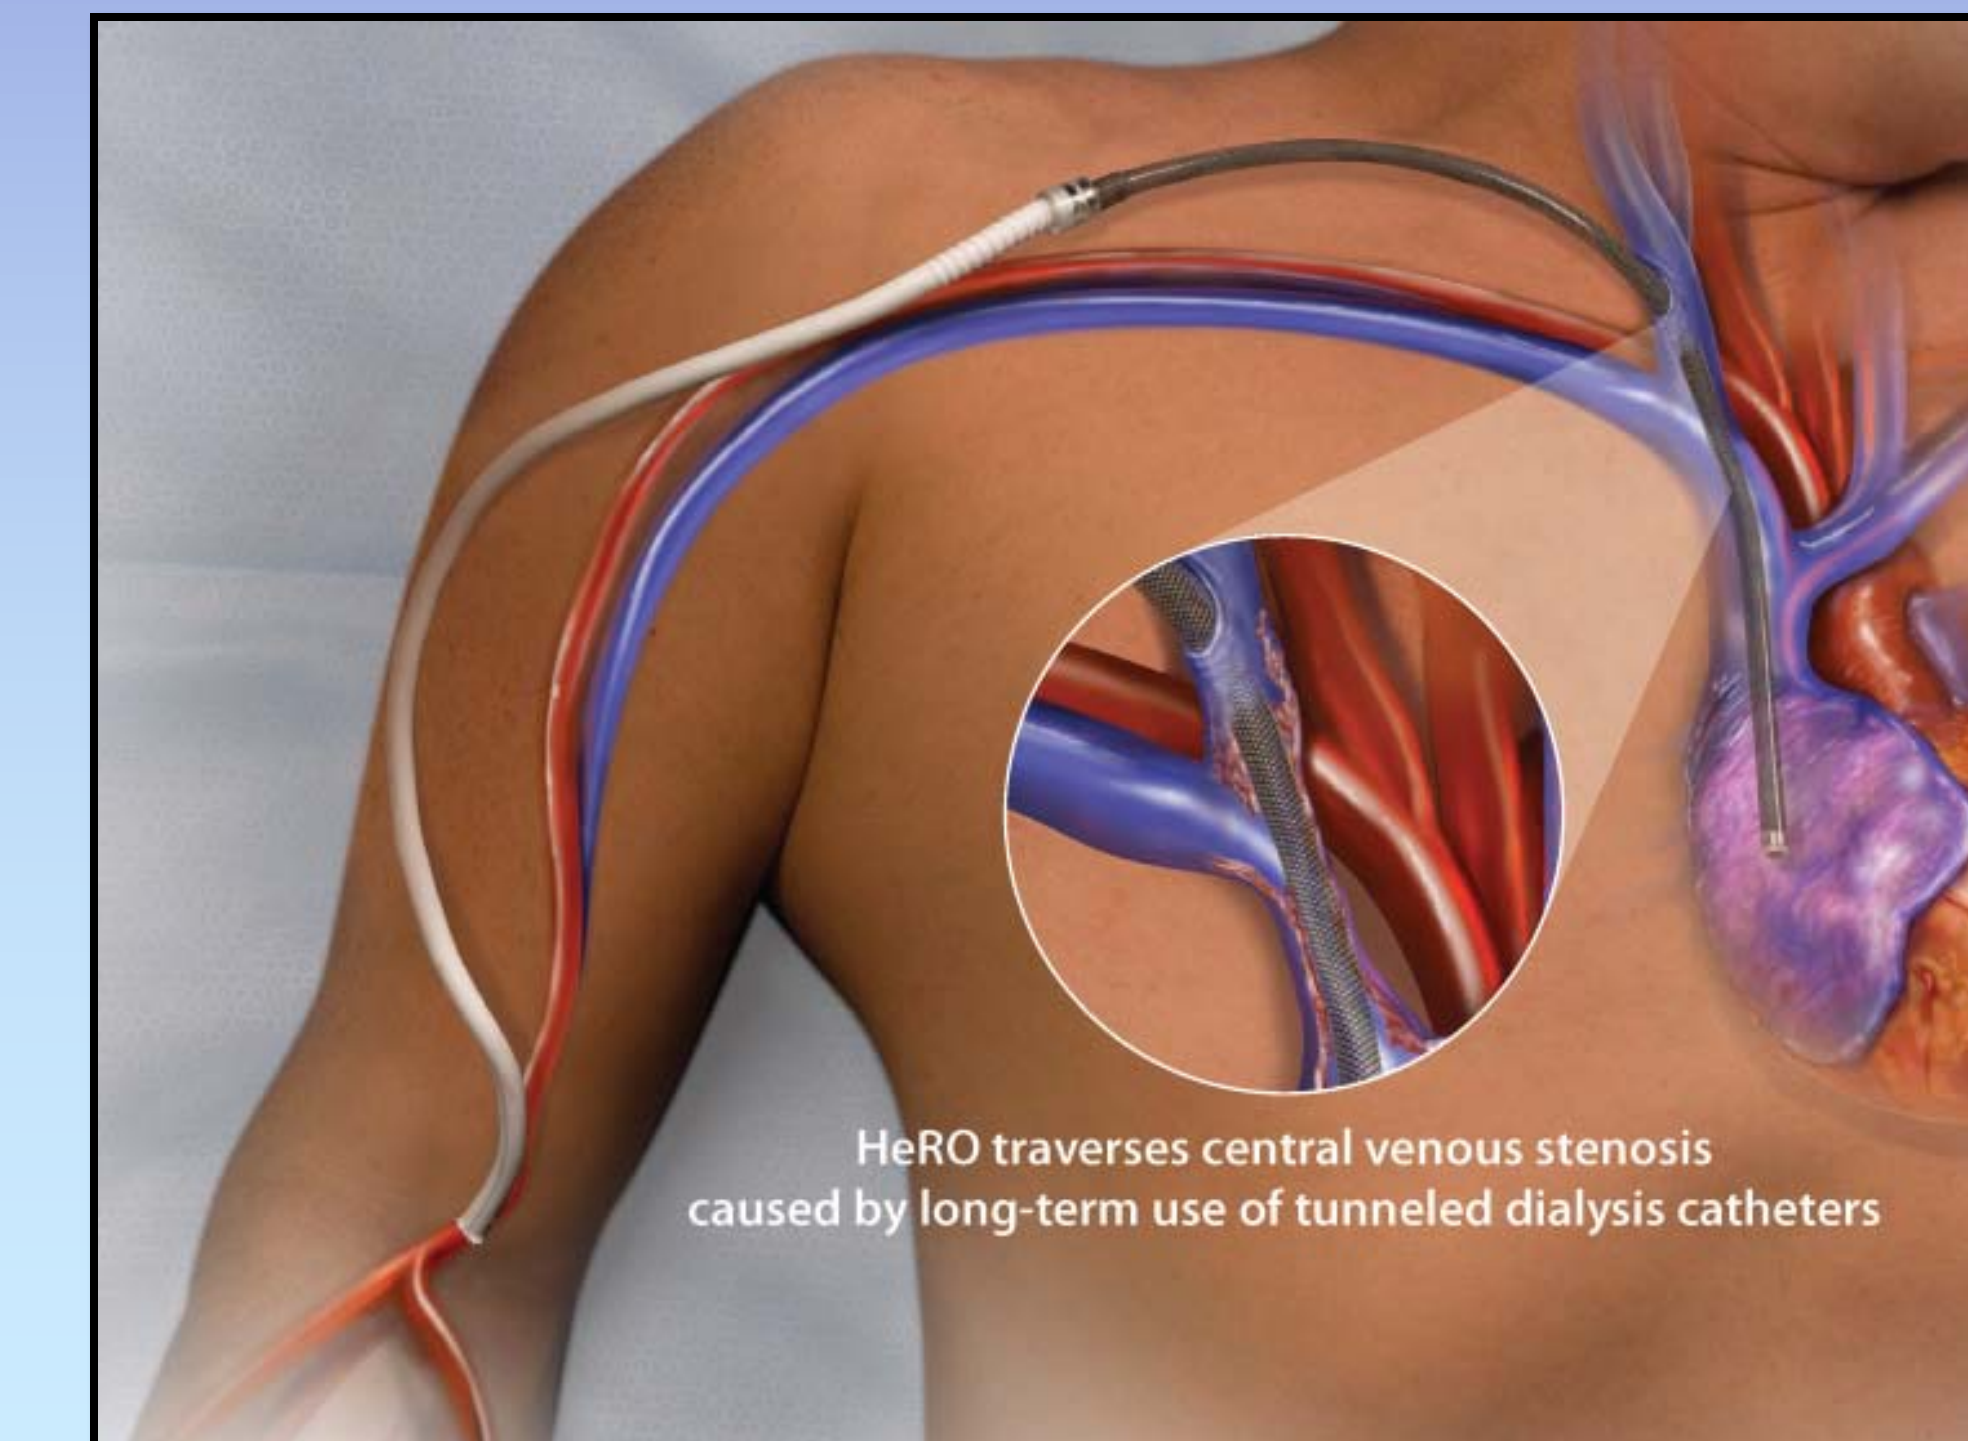
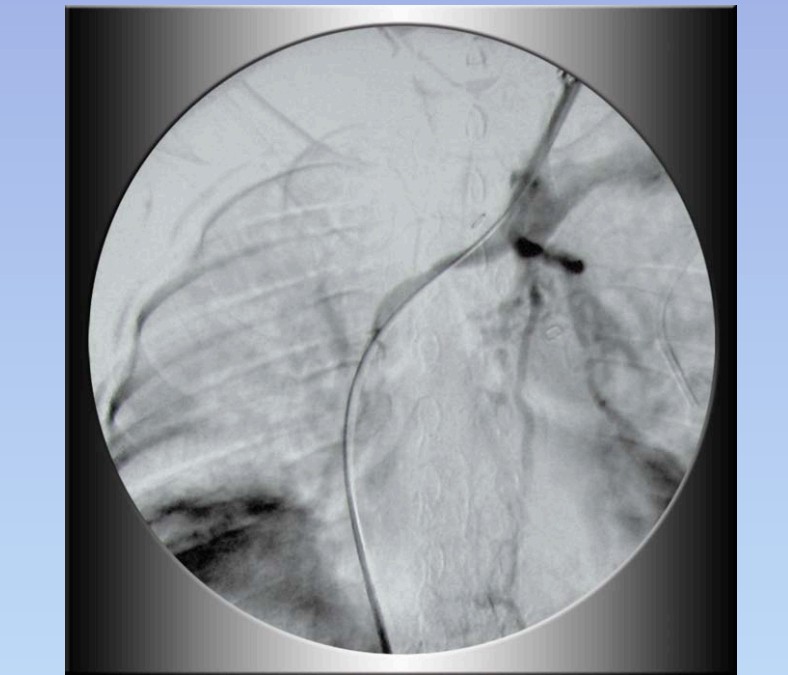
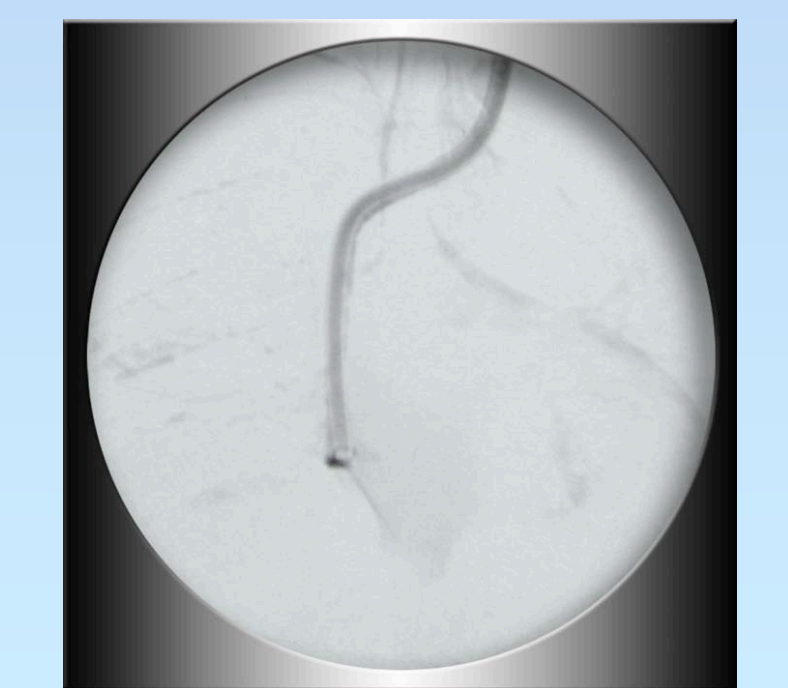
Images above reflect a typical HeRO access placement. No images from the referenced patient procedures were available. In the referenced procedures, the arterial anastomosis was connected to existing fistula rather than brachial artery. A bridging catheter was avoided and fistula was used for immediate cannulation.
